Inspection Report Minerals Regulatory Program June 21, 2010

Mine Name: Bawana Low Grade Ore Pile	Permit Number: S/001/0076
Operator Name: Western Utah Copper Company	Inspection Date: 06/21/2010
Inspector(s): Brett Gregory for Tom Munson <i>Thru</i>	Time: 2:30 pm
Other Participants: Ed Ginouves (BLM)	Mine Status: Active

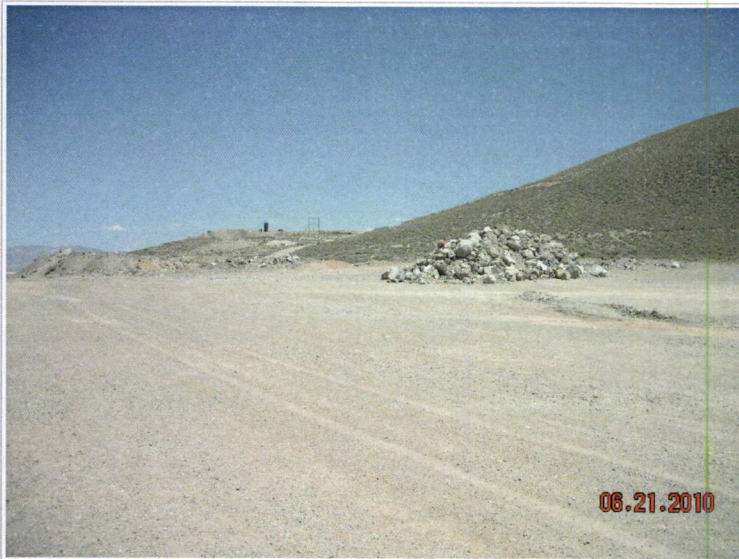
- 7) The material stockpiled appeared to be too large for a crushing operation. It may be best to bury the large material or use it as riprap at the toe of one of the excavated hillsides.
- 9) The in-situ topsoil appears to have become heavily compacted and will require ripping and pocking, or otherwise roughening of the surface, to help establish revegetation growth.
- 10) The Bureau of Land Management will provide a seed mix recommendation for the revegetation of the site. It is suggested to save the seed tags for confirmation of the seeding efforts made.
- 12) An earlier GPS map and recent photographs of the site are attached to this report.

Stockpiled ore to be removed.

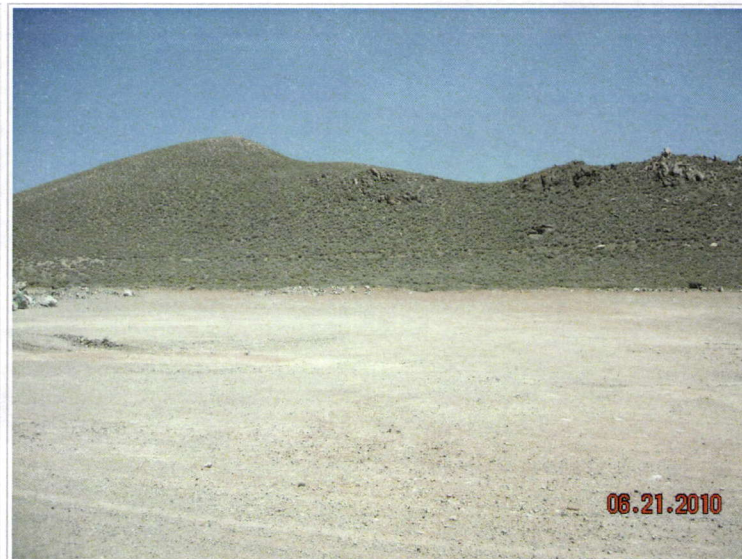
Compacted in-situ topsoil that will require ripping, pocking, and reseeded.

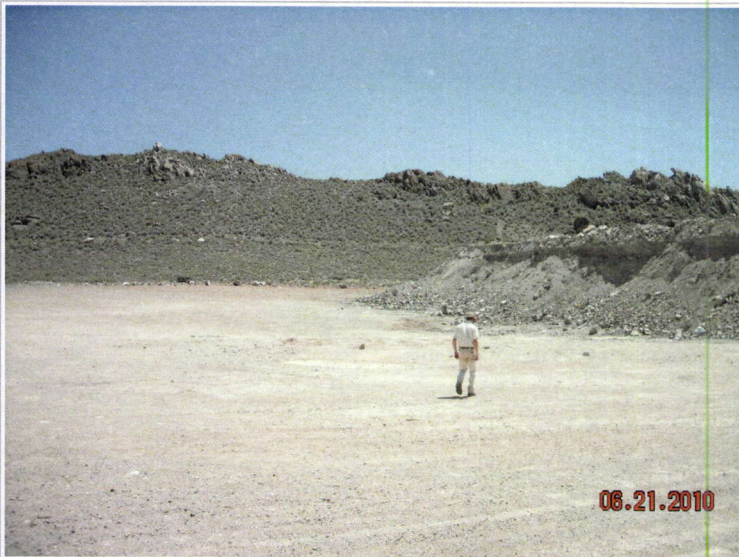
Plausible location to bury the stockpiled ore.

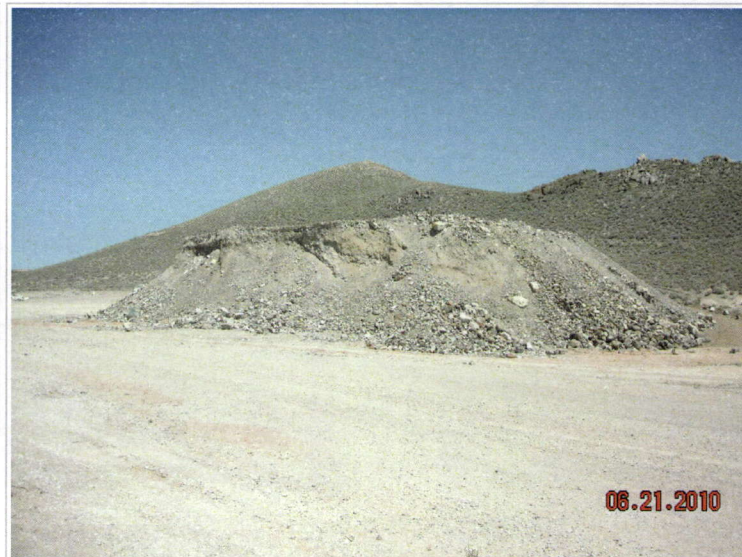
Area lacking topsoil for revegetation.

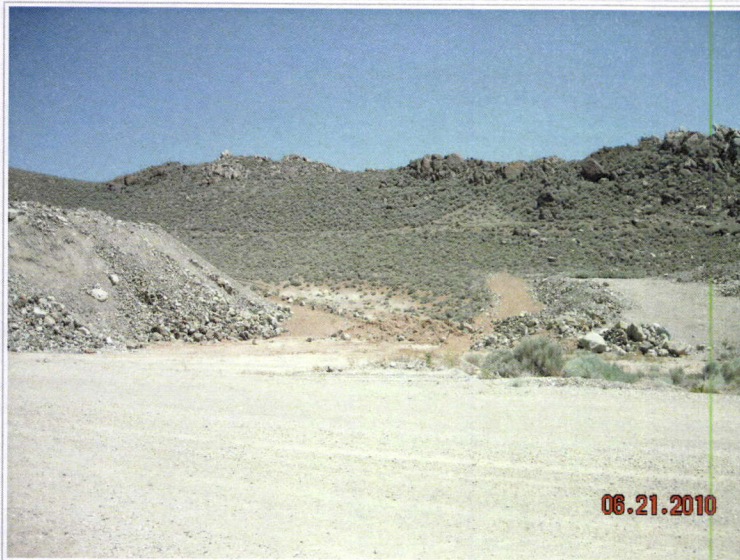
Disturbance that should be regraded to match the topography.

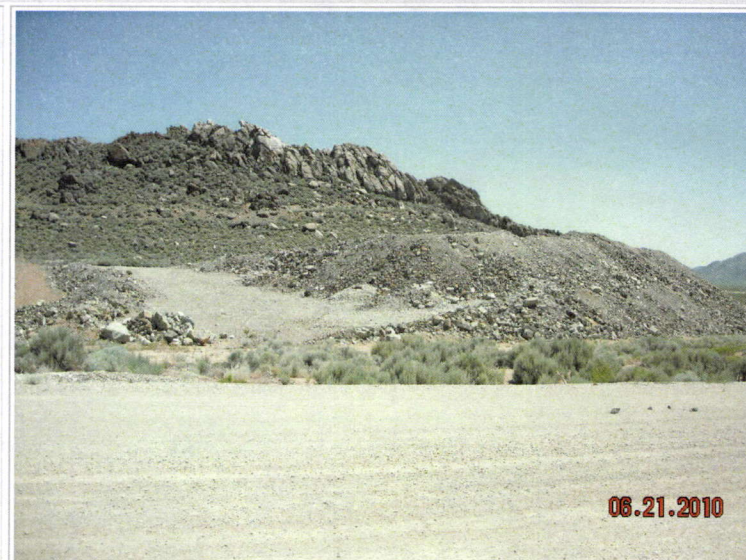
Disturbance that should be regraded to match the topography.
